# **GROUNDWATER SUPPLY ASSESSMENT PROPOSED GAN EDEN ESTATES THOMPSON AND FALLSBURG, NEW YORK**

February 2017

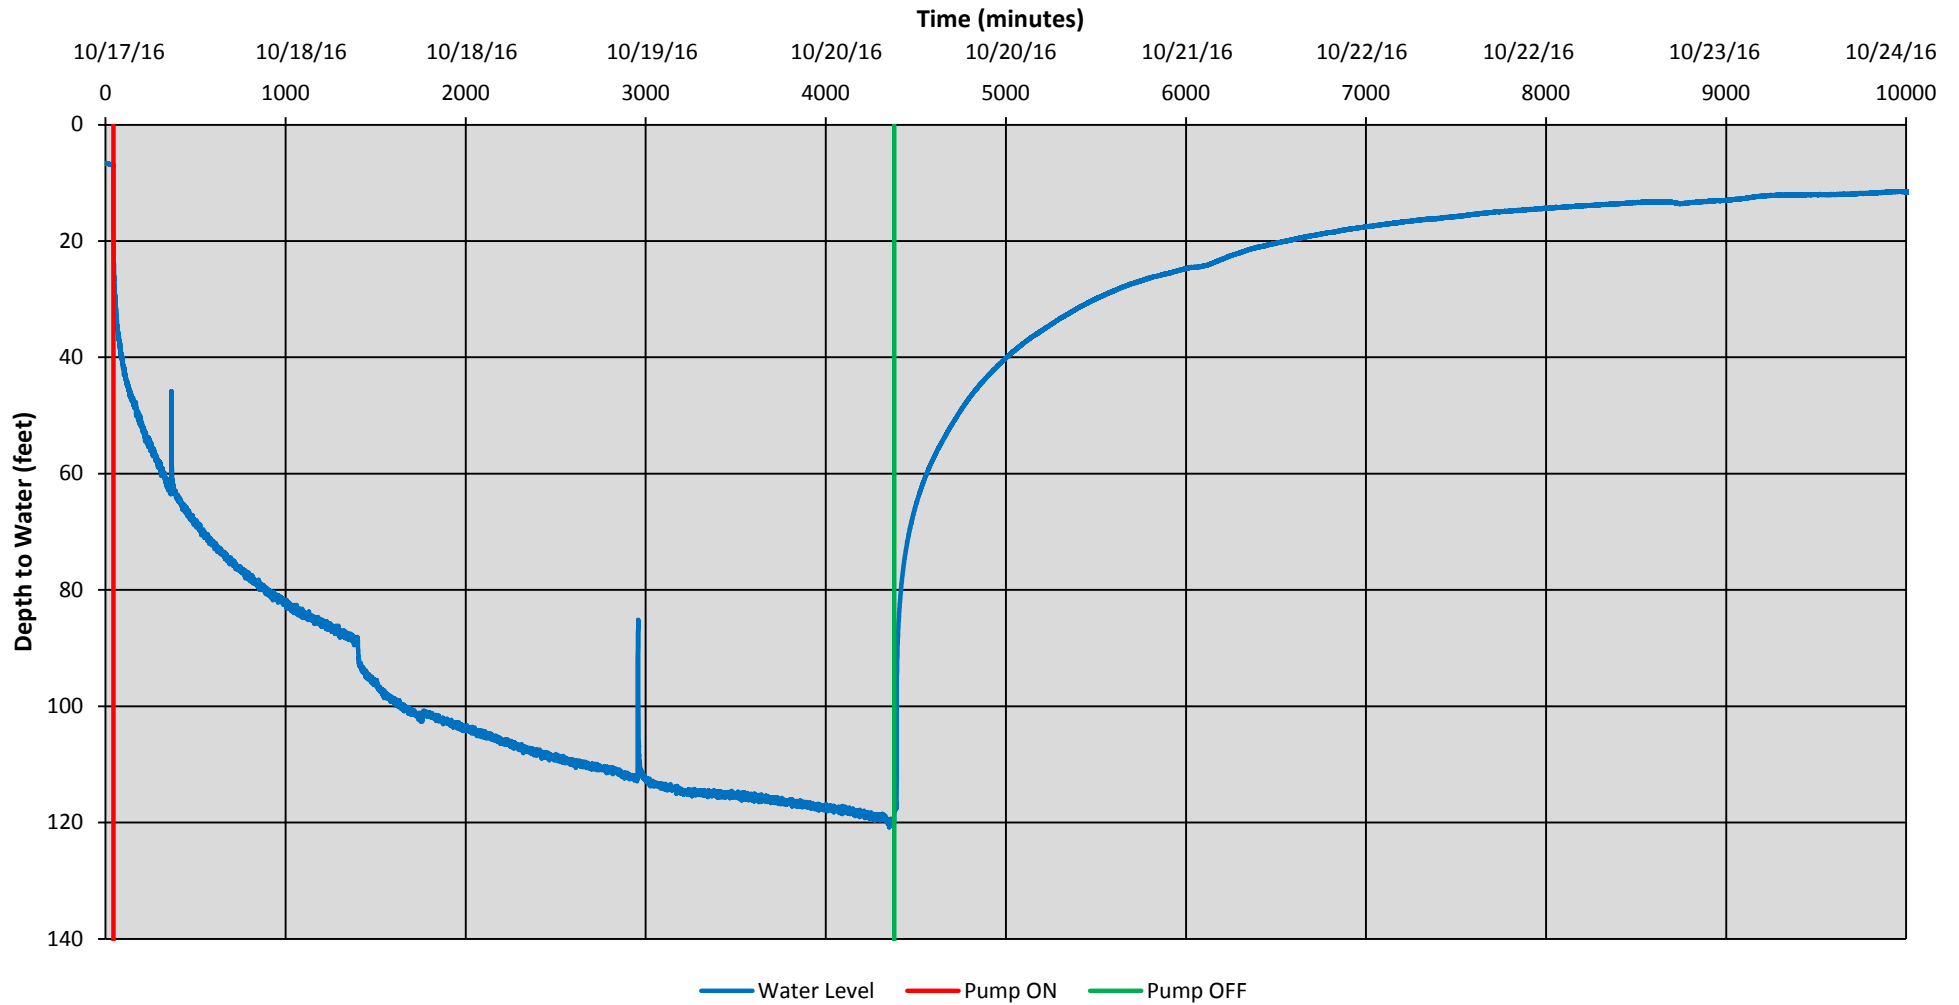
**Figure 4**  
**Proposed Gan Eden Estates Water Supply Assessment**  
**Thompson/Hurleyville, New York**

**TW-5 Pumping Well Hydrograph**  
**72-Hour Pump Test - 1**

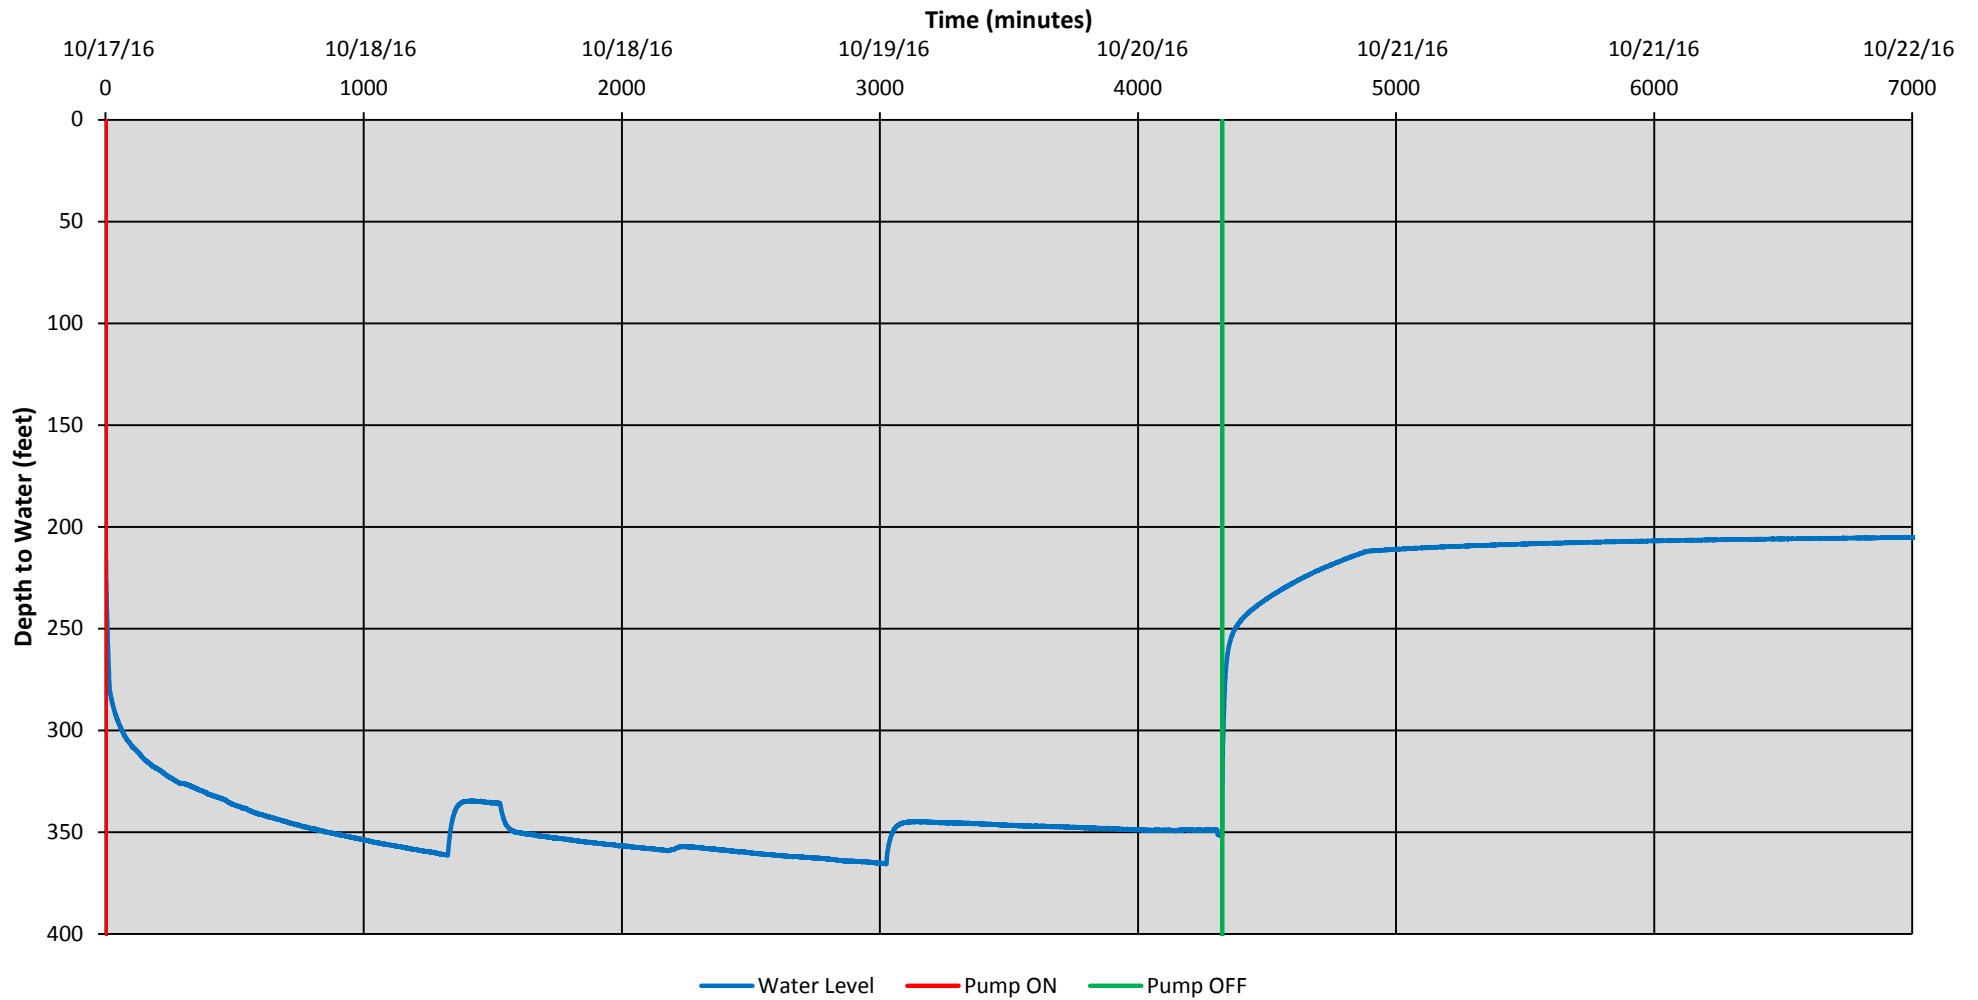
**Figure 5**  
**Proposed Gan Eden Estates Water Supply Assessment**  
**Thompson/Hurleyville, New York**

**TW-8 Pumping Well Hydrograph**  
**72-Hour Pump Test - 1**

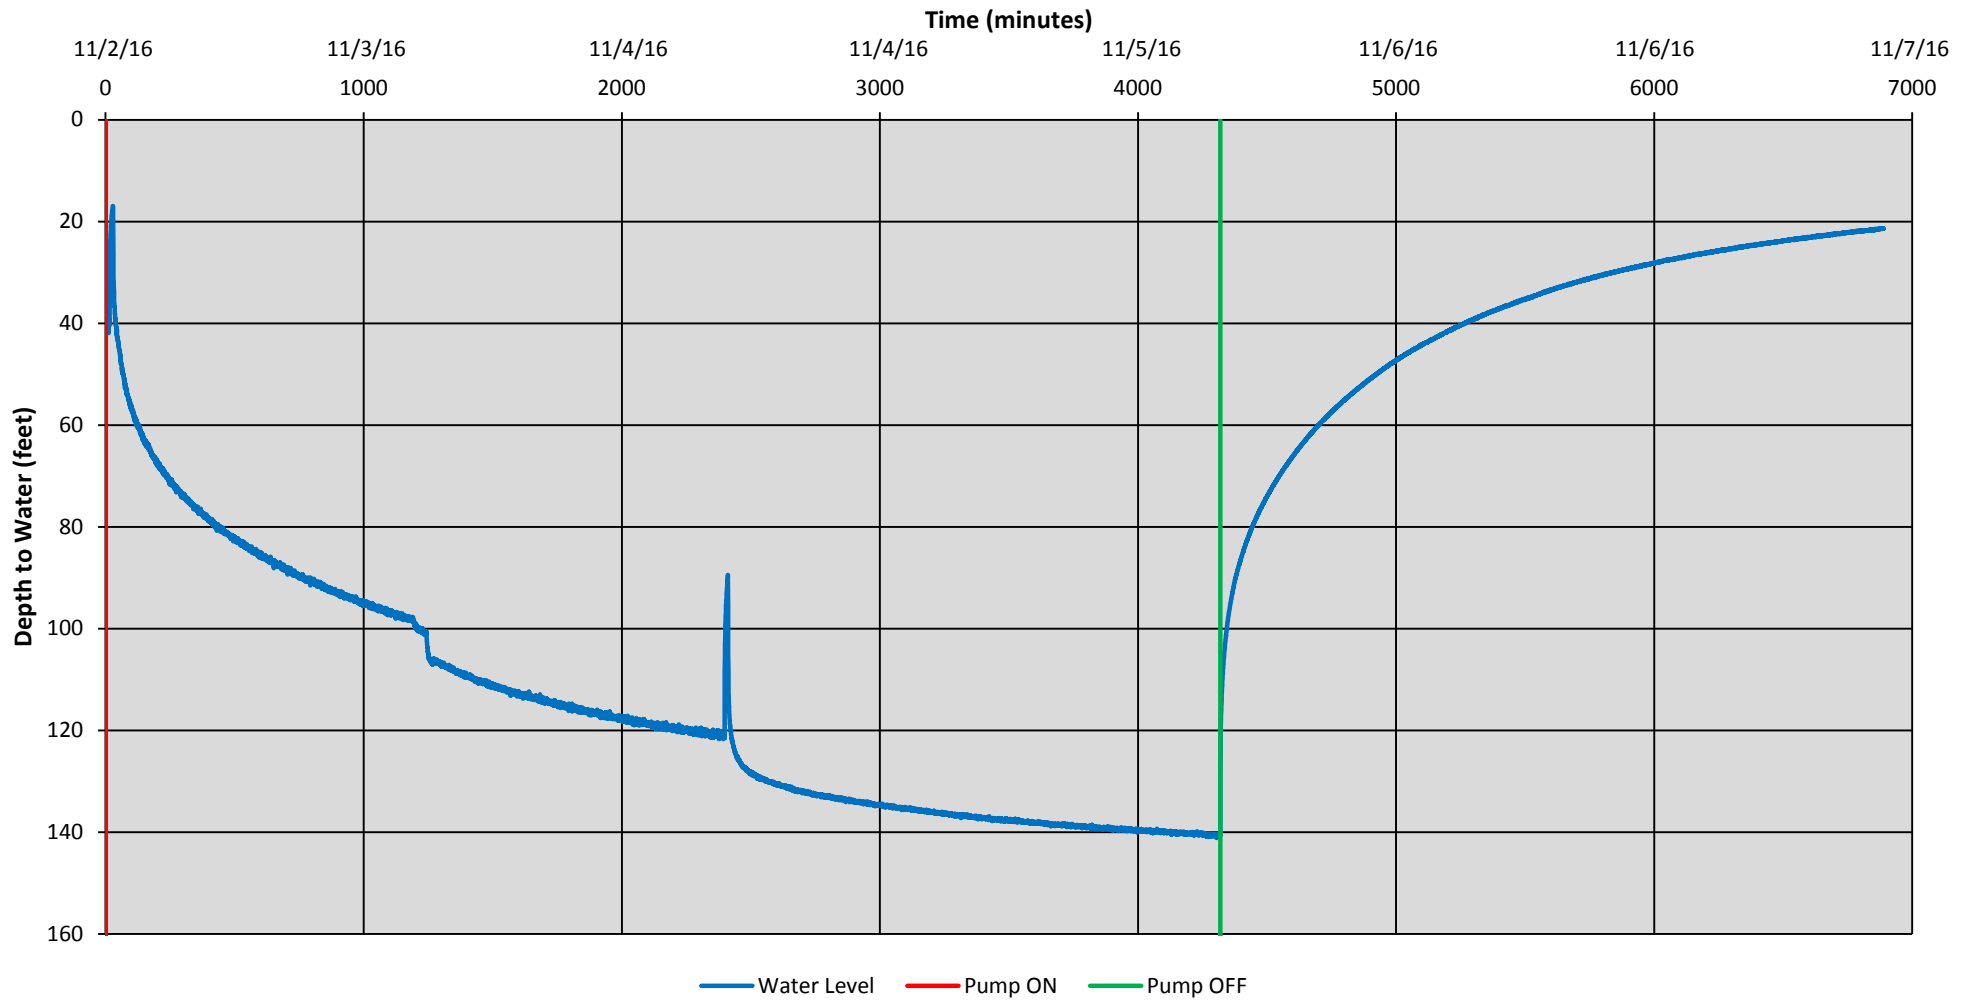
**Figure 7**  
**Proposed Gan Eden Estates Water Supply Assessment**  
**Thompson/Hurleyville, New York**

**TW-6 Pumping Well Hydrograph**  
**72-Hour Pump Test - 2**

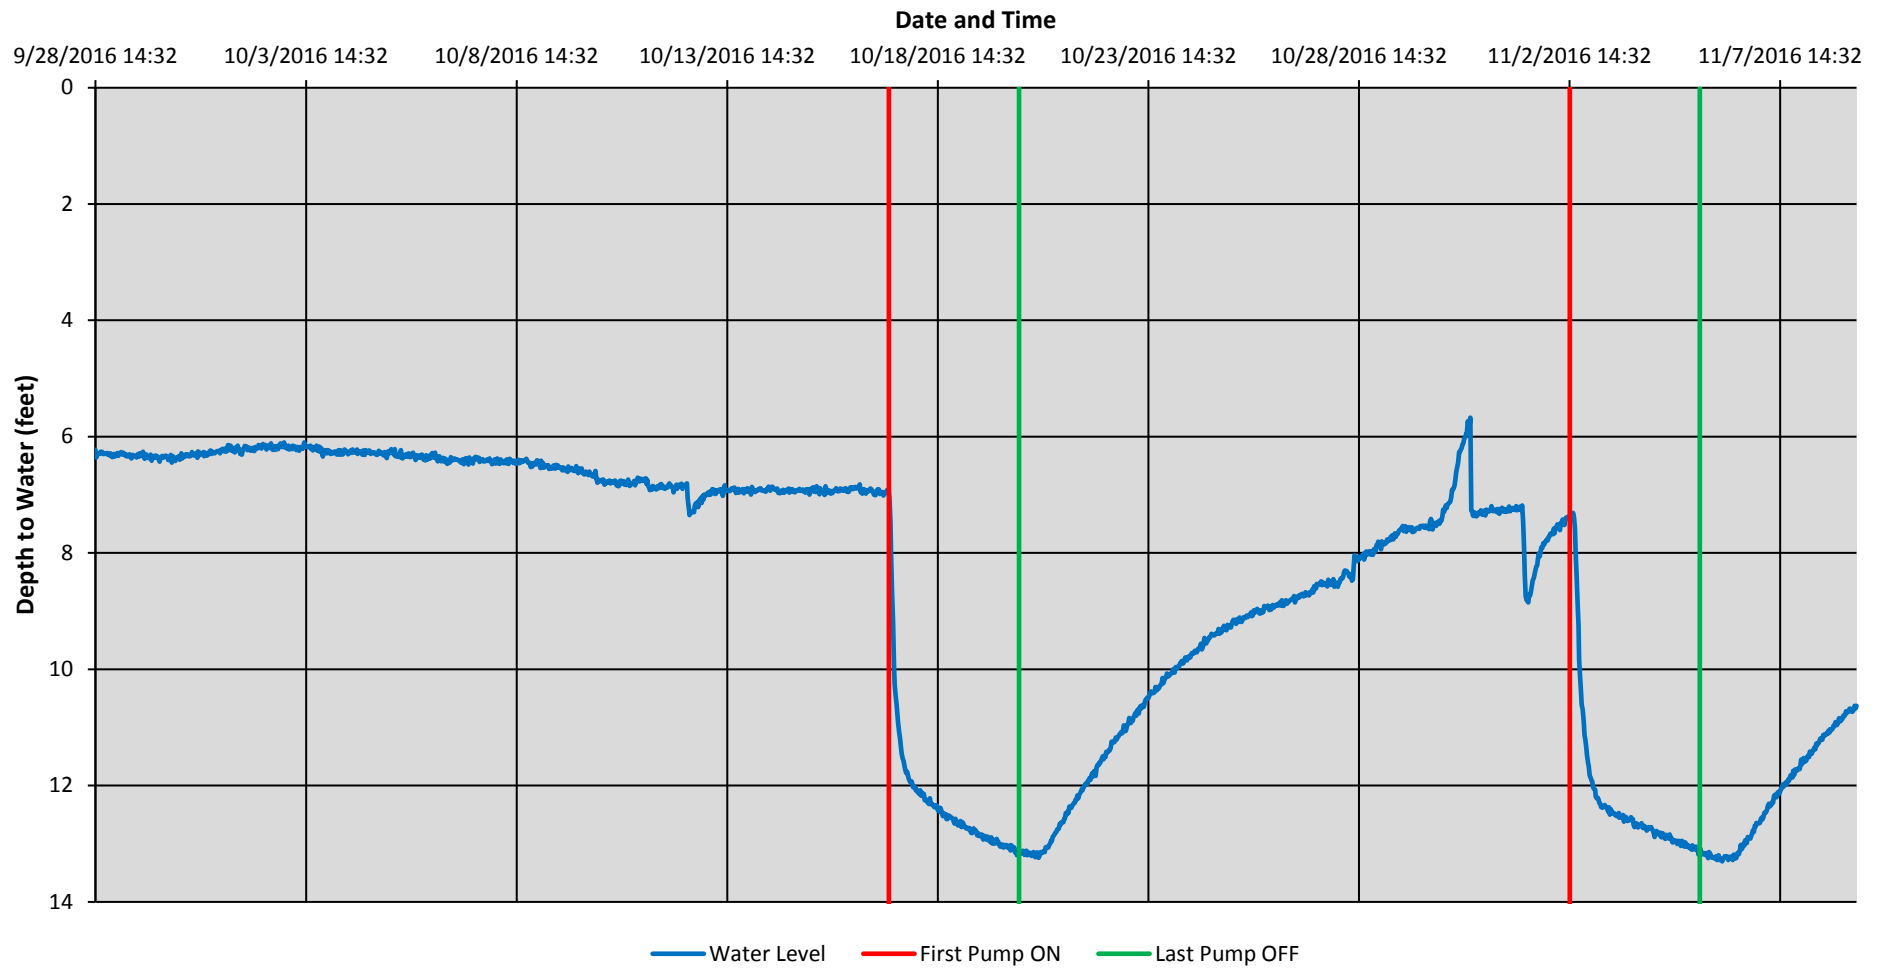
**Figure 11**  
**Proposed Gan Eden Estates Water Supply Assessment**  
**Thompson/Hurleyville, Sullivan County, New York**

**On-Site Monitor Well**  
**MW-1 Well Hydrograph**

None of the monitored surface water bodies observed any effects from this pump test (**Figure 25**). Discharge line locations were carefully selected to not to influence any nearby streams or water bodies (**Figure 2**). Although drawdown was observed in the shallow aquifer (MW-1) and wetland wells (P-1 and P-2) near TW-5 and TW-6, no measurable amount of surface water impacts were detected at any staff gauge location. Drawdown observed in MW-1 was 6.101 feet and in P-1 and P-2 was 1.089 feet and 0.673 feet respectively during pumping as shown on **Figures 11** and **12**.

Groundwater recharge effects can be observed on-site in the shallow monitoring well MW-1 (**Figure 11**) and piezometers P-1, P-2 and P-4 (**Figure 12**) hydrographs during the October 27, 2016, rain event. No recharge was recorded in any of the on-site bedrock test well hydrographs. Recharge was recorded in only two off-site wells, the Cole Well (**Figure 15**) and the Fallsburg Well H-1 (**Figure 24**) following the October 27, 2016, rain event. The results of rainfall monitoring are included on **Table 4**.

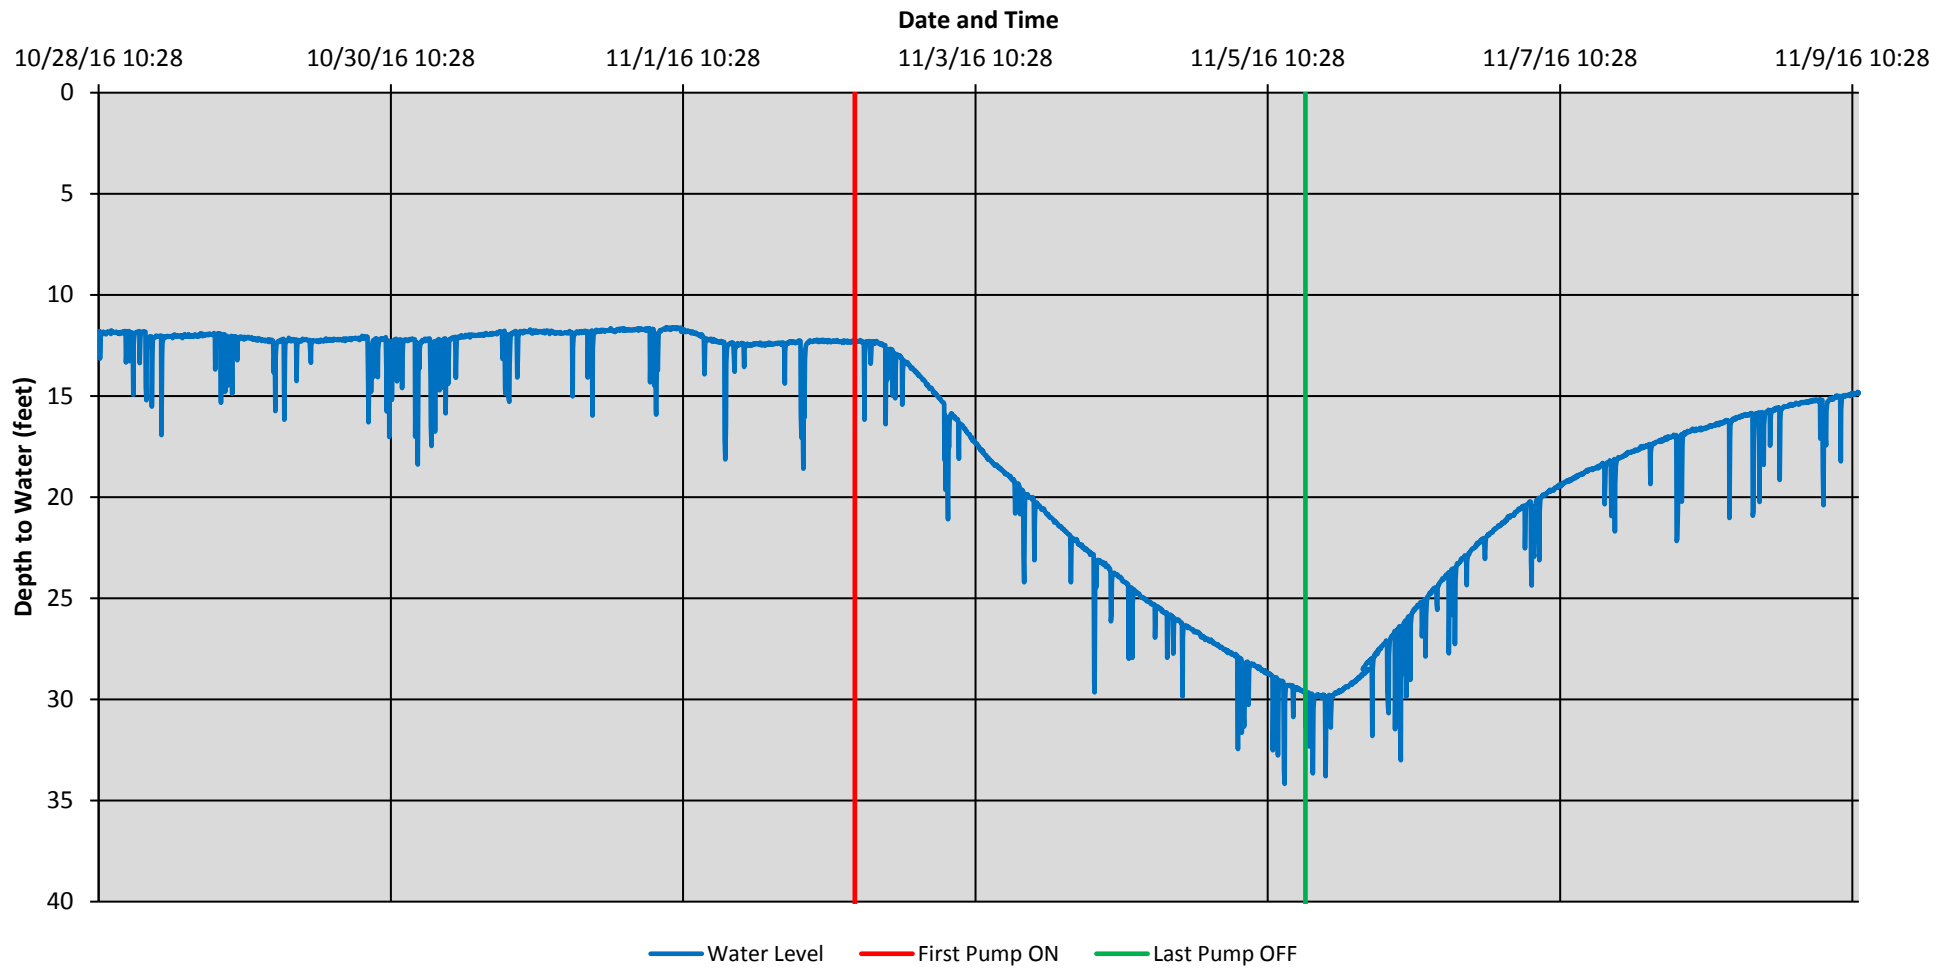
**Figure 18**  
**Proposed Gan Eden Estates Water Supply Assessment**  
**Thompson/Hurleyville, Sullivan County, New York**

**Off-Site Monitor Well**  
**Hobby Well Hydrograph - Pump Test 2**

pump test, the Hobby Well, located approximately 1.03 miles northwest of the site at 273 Mongaup Road, experienced approximately 15 feet of drawdown during the pumping period. This amount of drawdown is significant and may have been enough to cause the change in water quality that the homeowner reported.

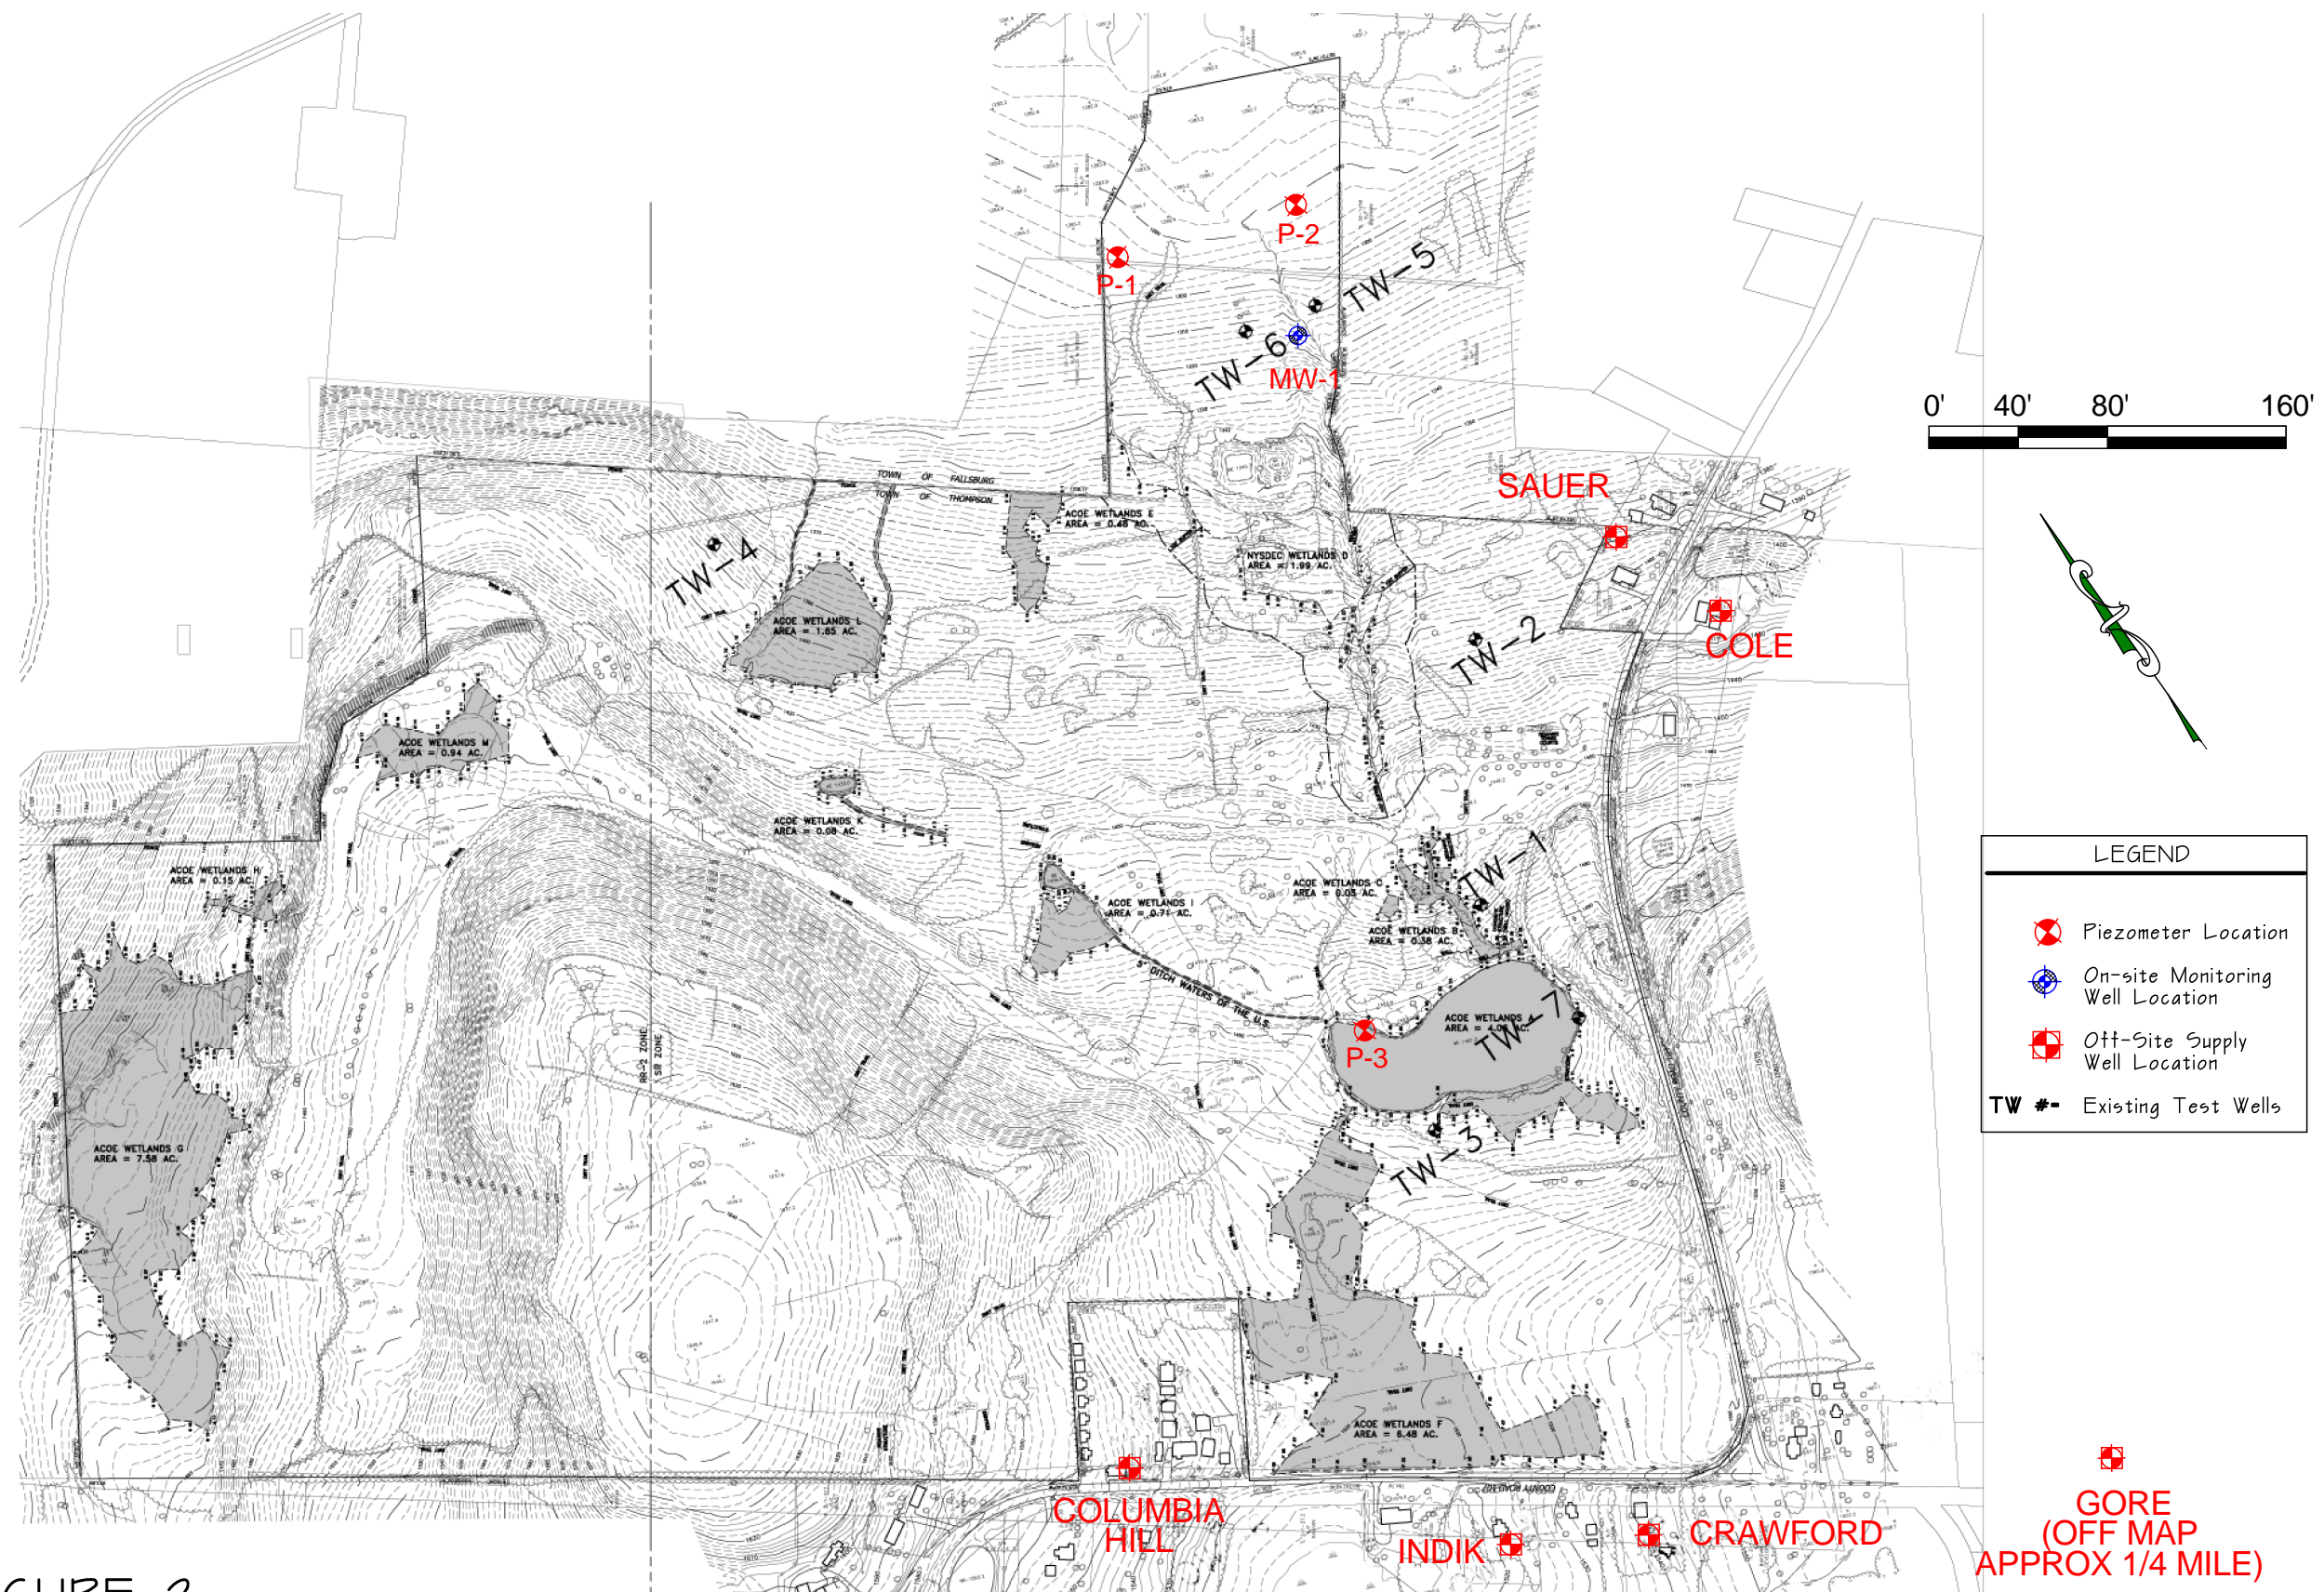
FIGURE 2

GAN EDEN ESTATES  
THOMPSON & HURLEYVILLE, NEW YORK

test along with the piezometers and on-site monitoring well. The locations of these wells are shown on **Figure 2**. The Geologic Logs for P-1, P-2, P-3, P-4 and the drilled well, adjacent to two of the pumping wells, MW-1, are included in **Appendix 4**.

HES canvassed the off-site area surrounding the proposed Gan Eden Estates property with respect to pumping wells to obtain homeowner permission to monitor existing residential supply wells during the pumping test periods. Permission for a total of 12 off-site wells, including 11 residences and one Town of Fallsburg well, was granted to HES to monitor their supply wells during the pumping tests (**Table 2**). Initially 10 wells were monitored during the first 72-hour pump test and two more local residences requested to have their wells monitored prior to the start of the second pump test. Beginning several days before initiation of the two 72-hour pumping tests, HES monitored the off-site supply wells from the area surrounding the well field. All of these wells are individual residential supply wells with the exception of the Park Slope well which services a group of cottages and the Fallsburg Town well which supplies multiple residences in the area. The observation wells were monitored on a daily basis before, during and after the pumping test at set intervals using pressure transducer data loggers installed in each of these wells and manually at times as a cross-check to the transducers. The off-site monitoring well locations with respect to the site and test wells are shown on **Figure 2**.

HES installed staff gauges in surface water bodies and kept photo logs of each gauge. A total of three staff gauges (SG-1, SG-2 and SG-3) were installed on- and off-site to monitor surface water impacts. SG-1 was installed on-site in a small flowing stream approximately 150 feet northeast of TW-5. SG-2 was installed on-site in a shallow pond between TW-3 and TW-5 and TW-6. SG-3 was installed off-site just off the bank of the Mongaup River where it passes beneath Columbia Hill Road to the north of the site. Locations of the three staff gauges are shown on **Figure 2**.

During, before and after the 72-hour pumping test, HES monitored selected wells in the vicinity of the subject site. One monitoring well, two piezometers (P-1 and P-2) and two test wells were monitored on-site during this time period. The locations of these wells are shown on **Figure 2**. The geologic logs for P-1, P-2 and the drilled well adjacent to the pumping wells, MW-1, is included in **Appendix 4**.

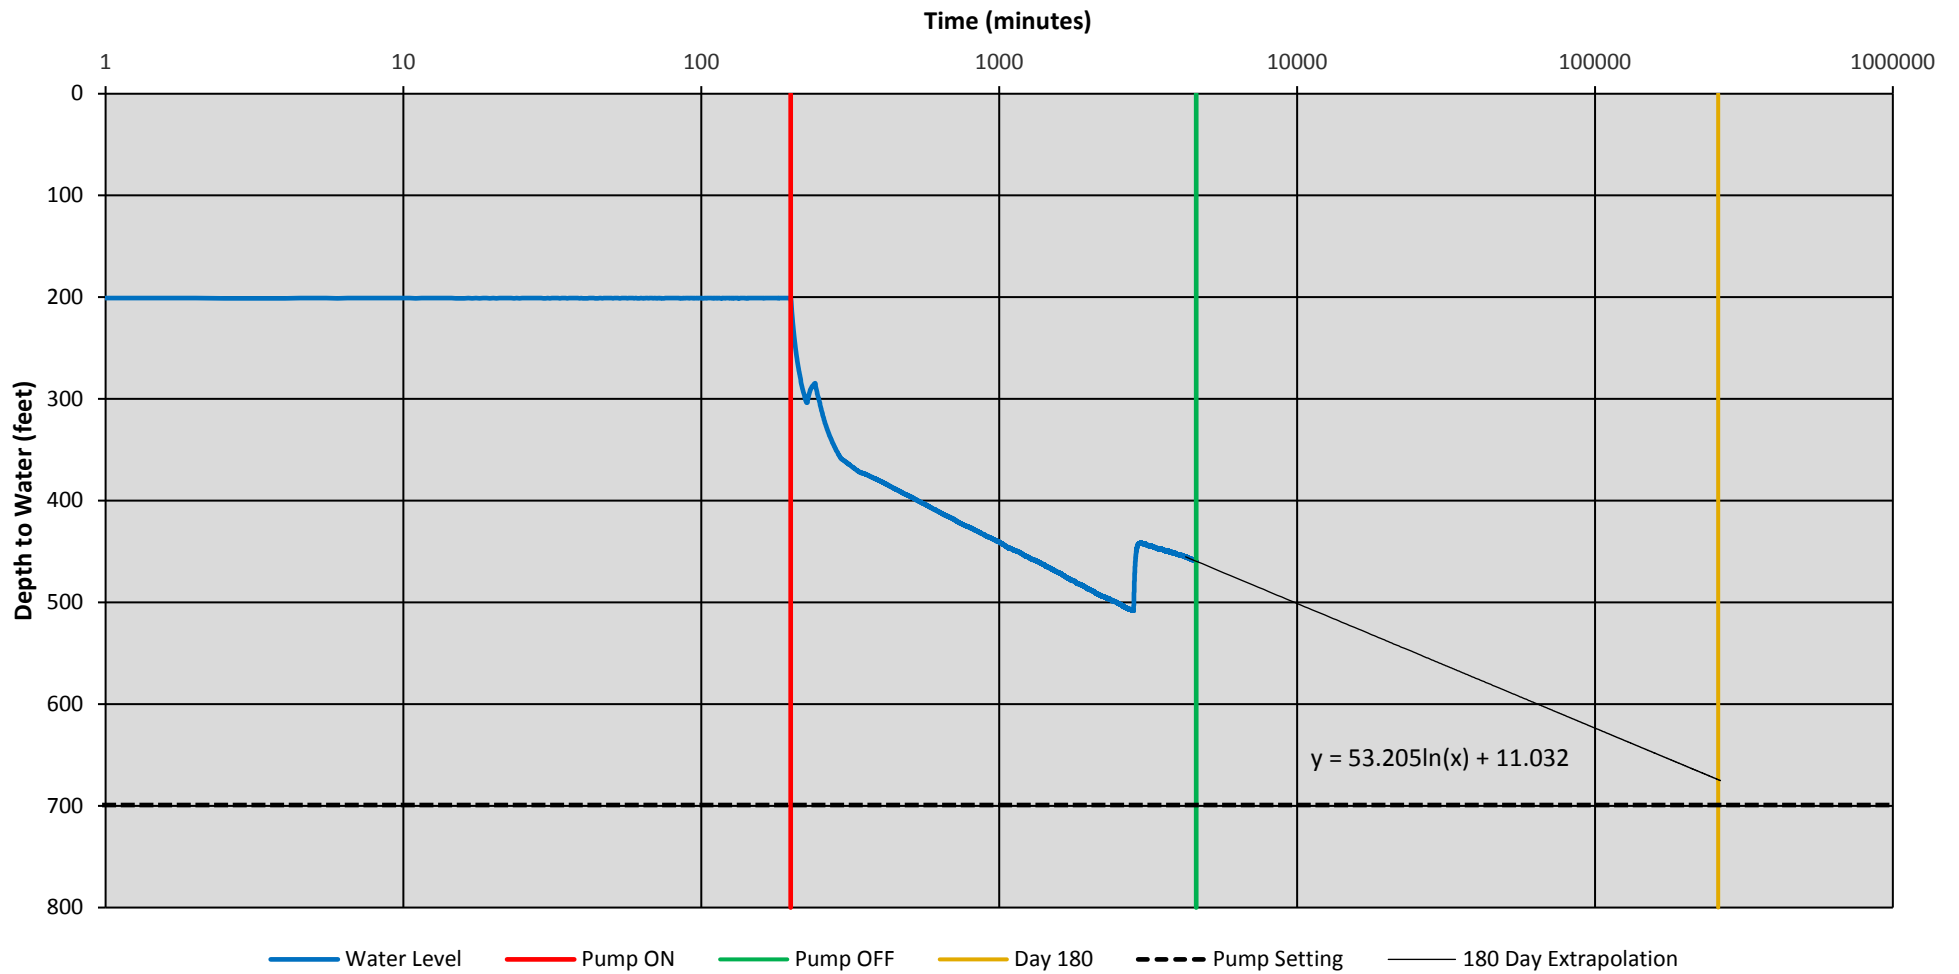
TW-8 Pumping Well Hydrograph  
72-Hour Pump Test - 2  
(180 Day Drawdown Extrapolation)
